Analysis of semiconductor fault using DS (damped sinusoidal) HPEM injection

ABSTRACT

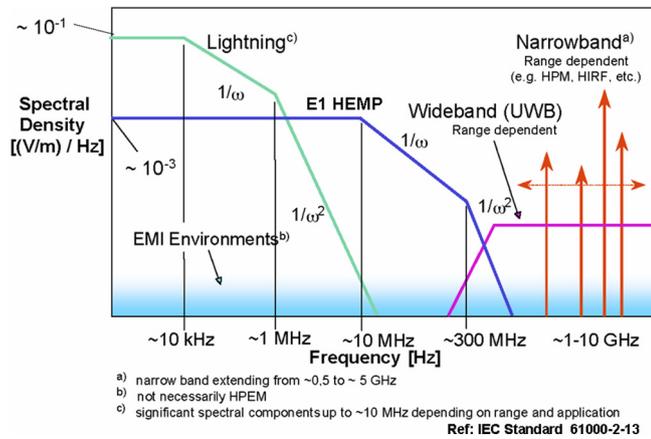
Fig. 1 illustrates the simplified High Power Electromagnetic (HPEM) environment. Therefore, the susceptibility of electronics to pulsed

Fig. 1. HPEM environment.

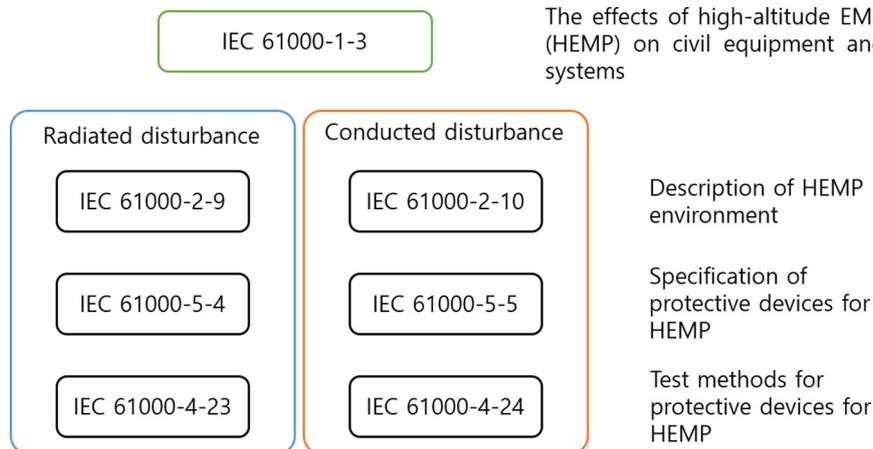
The IEC standard and technical reports on High-altitude EMP (Electromagnetic Pulse) have been mainly published on evaluation standards for systems and fixed facilities, yet no standard document on individual semiconductor devices has been published [5–11] (Fig. 2).

Fig. 2. International standard for HEMP protection.

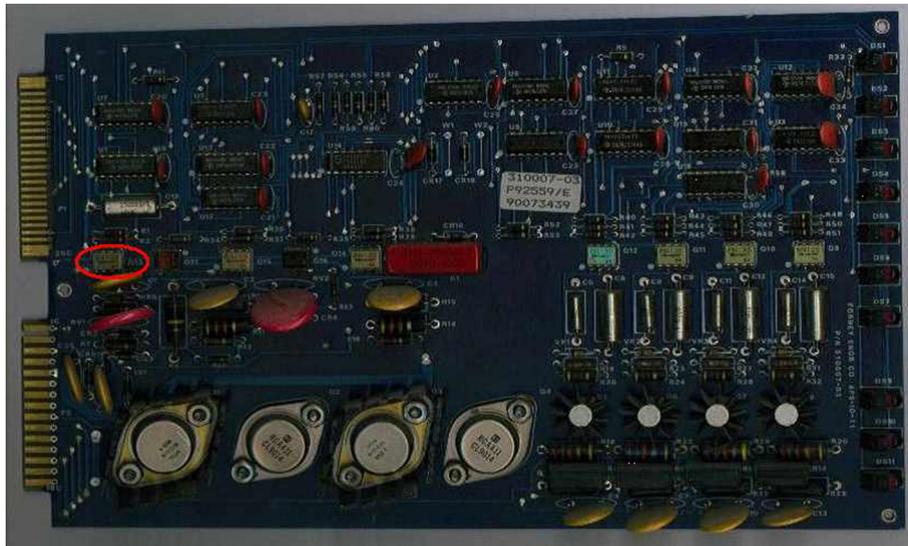
precise, in Fig. 3, a defect in the On/Off function of the phototransistor in the red circle was found.

Fig. 3. The original board.

It may be necessary to begin with a brief history of the boards used in this test. This test board was first used in a nuclear power plant and had a history of replacement due to functional problems. After that, the cause of the failure was analyzed and it was proved that there is a fault in the device that processes the input of the logic circuit. To be more

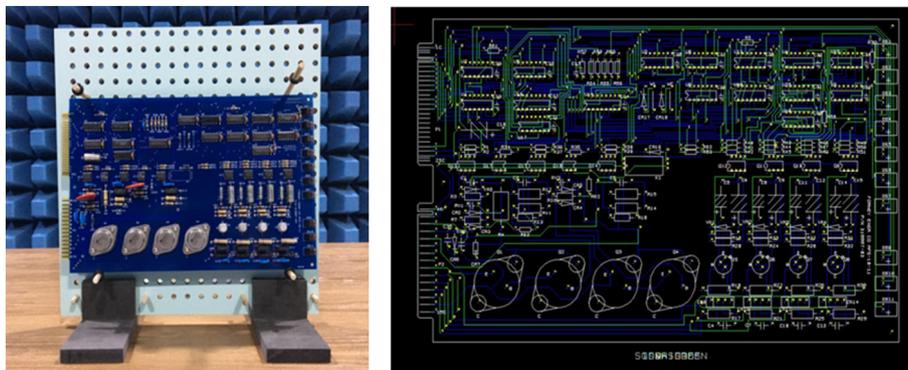
The reason for replicating the pattern of this test board is that the radiated DS HPEM is known to affect the device by being coupled to the copper pattern of the board. Thus the position and length of the copper pattern in the board is a very important factor in HPEM experiments [13, 14] (Fig. 4).

Fig. 4. The replicated test PCB.

For this experiment, we exactly replicated the manufacturer, the position of the parts, and so on of the original board. It took a great deal of time and effort to understand the information on the board as it was built and used 20 years ago in order to make it exactly the same again.

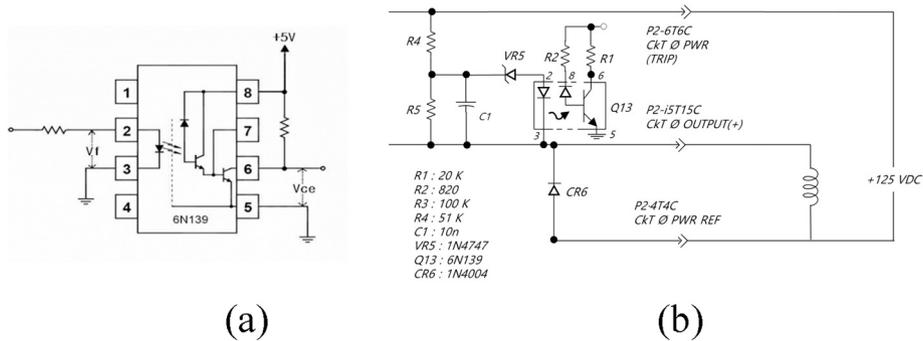
The part that caused the problem with the defect on the test board is the 6N318 (High Gain Darlington Phototransistor), shown in Fig. 5. In a Phototransistor with a defect, even if a turn-on voltage (V_f) is applied to the input LED (between pin 2 and 3), the phototransistor is not completely turned on and a considerably large V_{ce} voltage is detected.

Fig. 5. (a) 6N138, (b) test circuit for HEMP.

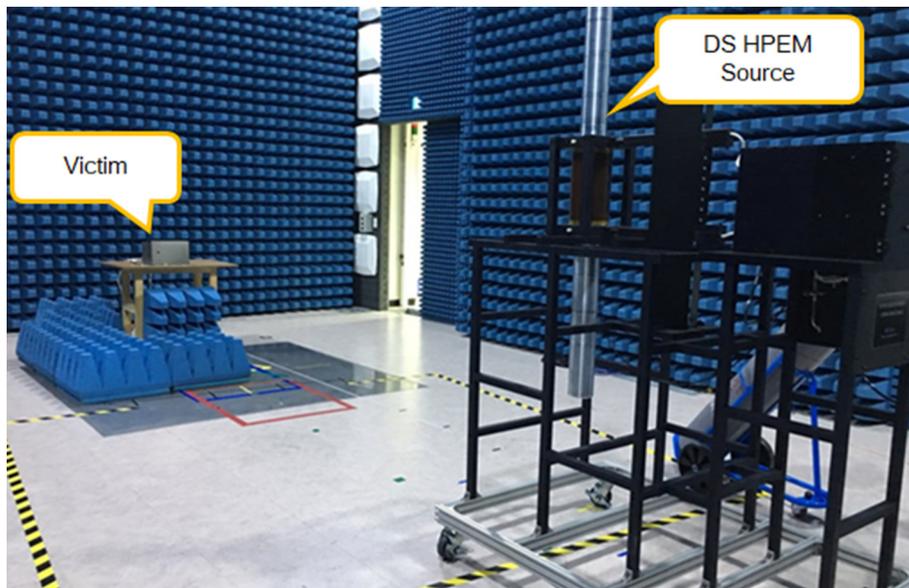
We carried out injection tests of a high altitude electromagnetic pulse (HEMP) where a frequency component of 80 MHz to 500 MHz generated from a damped sinusoidal electromagnetic pulse generator corresponding to IEC 61000-4-36 is applied to a printed circuit board through radiation. Table 1 shows the specifications and characteristics of the DS HPM source used in the test (Fig. 6).

Fig. 6. DS HPEM source in anechoic chamber.

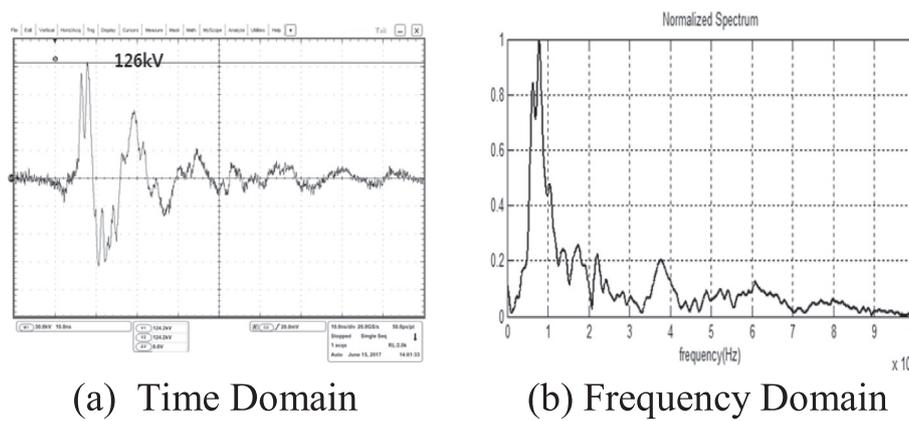
Table 1 and Fig. 7 show the specifications and characteristics of the DS HPM source used in the test.

Fig. 7. DS HPEM source characteristics (@10 m).

Category	Specification
Peak E-field strength	12 kV/m@10 m
Center frequency	80–500 MHz
Damping factor	1–20
Burst duration	1–10 s
Pulse repetition frequency wave form	1–10 Hz
Far voltage (rE)	Damped sinusoidal 125 kV

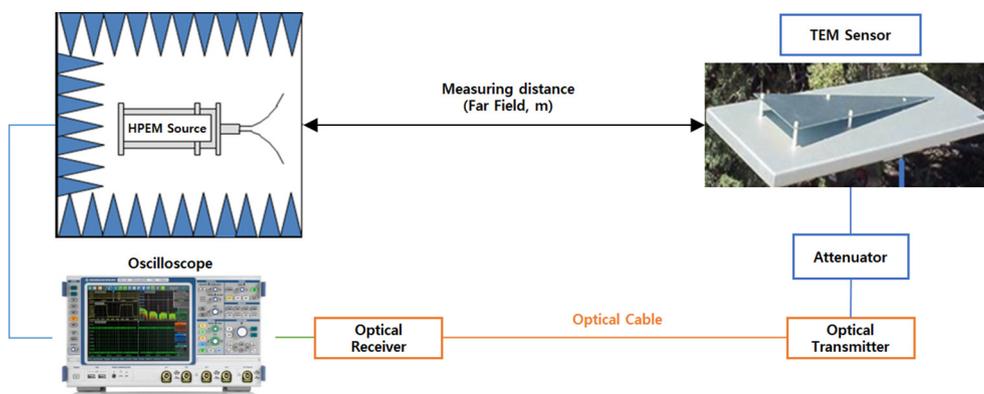
Fig. 8 shows the test setup to verify the compatibility of the

anechoic chamber under test by measuring the electromagnetic field strength along the distance. Fig. 9 shows that EM field strength (E) exhibits relatively linear attenuation. (* “rE” is the measured value, and “E” is the calculated value.) If the anechoic chamber is not shielded from the external electromagnetic environment, or if the HEMP radiated is not absorbed from the wall, this conversion value “E” (kV/m) may not be linear.

Fig. 8. EM field measurement setup.

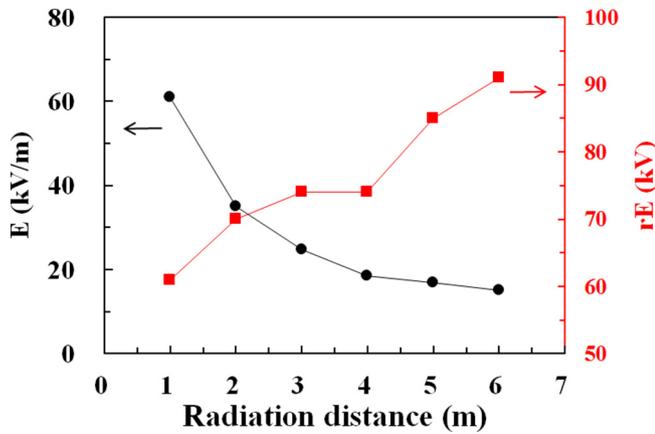
Fig. 9. EM field strength.

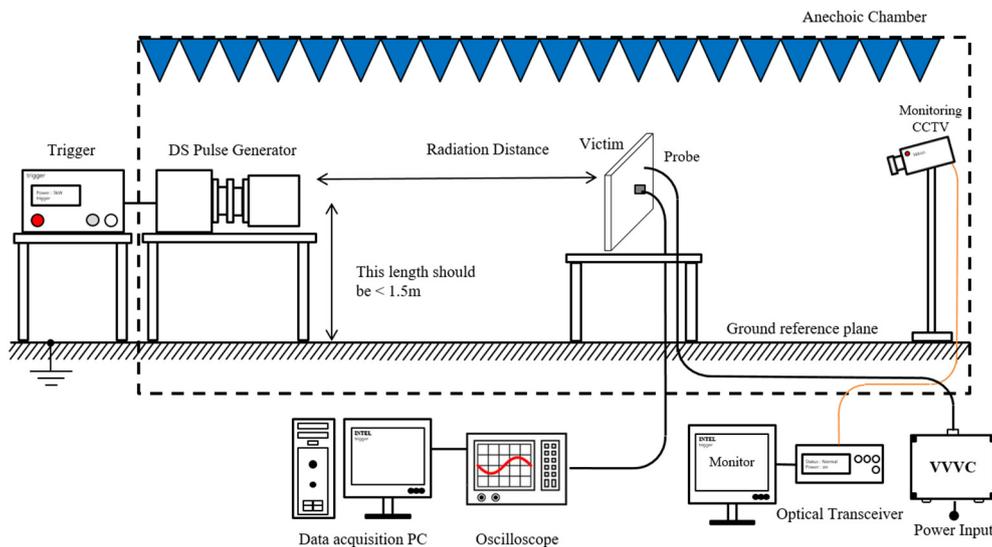
Therefore, we verified the compatibility of the experimental space with the distribution of E (kV/m) values of rE (kV) divided by distance (Fig. 10).

Fig. 10. EMP injection test configuration.

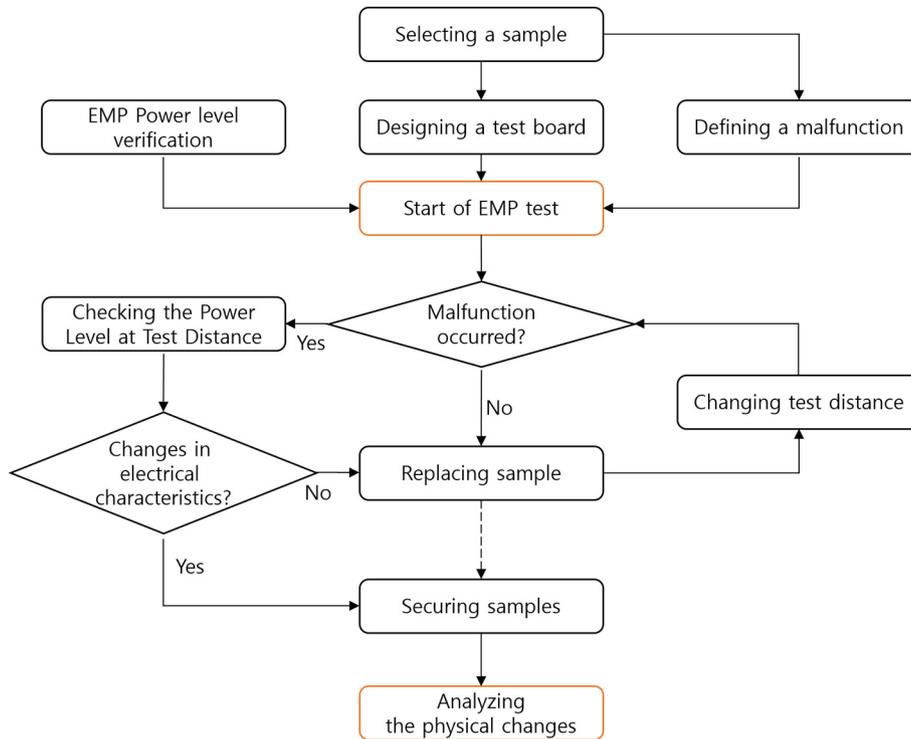
Fig. 11 shows a flow chart for evaluating the effects of the semiconductor devices on HPEM.

Since the intensity of the EM field is linearly damped in proportion to the set distance, we evaluated the influence of the test device by moving the source at intervals of 1 m starting from 6 m and ending at 1 m. The reason for adjusting the EM field intensity applied to the sample by adjusting the distance is that the IEC 61000-4-36 standard specifies only the peak E-field strength of the DS HPEM simulator at 10 m to 12 kV/m.

Fig. 11. Fault injection test sequence.

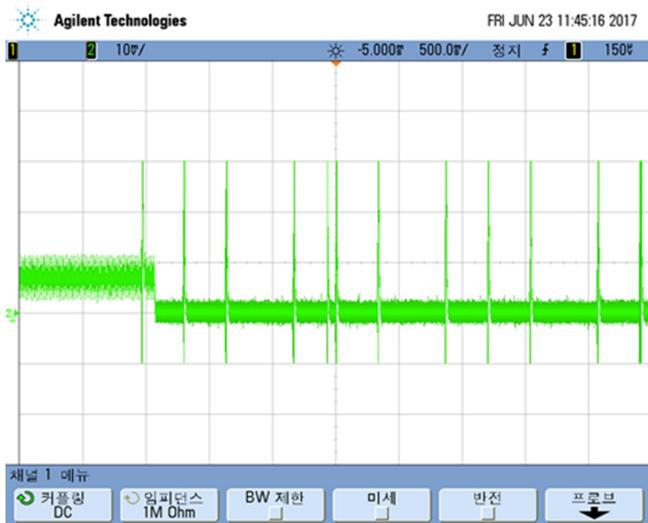
Fig. 12 shows the waveforms measured by oscilloscope for the coupling phenomena measured in V_{ce} . The coupling phenomenon is not limited to V_{ce} but occurs throughout the target board. For this reason, the magnitude of the pulses measured by the oscilloscope becomes very unreliable and is used only to confirm that the coupling phenomenon has occurred.

Fig. 12. Coupling phenomenon at V_{ce} .

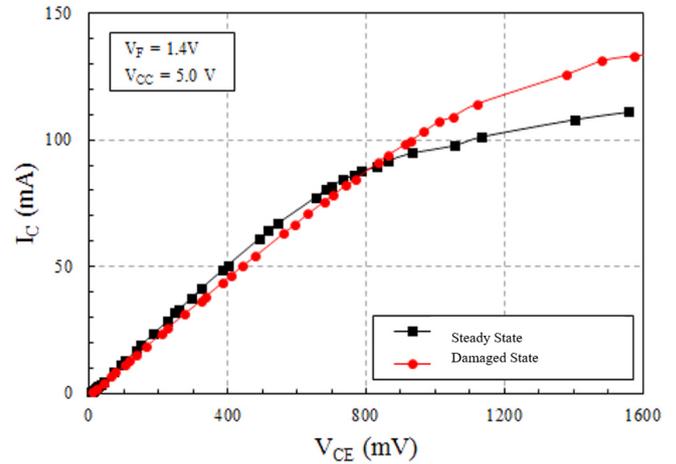
In Fig. 13, DS HPEM injection has induced physical damages shown by the analysis of the sample. An emissive microscope was used to analyse the internal defect inside the phototransistor. The leakage current increased due to the internal defect (damage) at the base end, and the occurrence of the defect was confirmed.

It was confirmed that the IC value (@ V_{ce} 20 mV) of the Phototransistor at the output part of the phototransistor tested at the emission distance of 2 m was increased by about 100 μ A, from 879 μ A to 1004 μ A, as compared with that of the normal parts. The increase in the leakage current injected by DS HPEM was caused by physical damage of the semiconductor.

Fig. 13. Curve tracer measurement results.

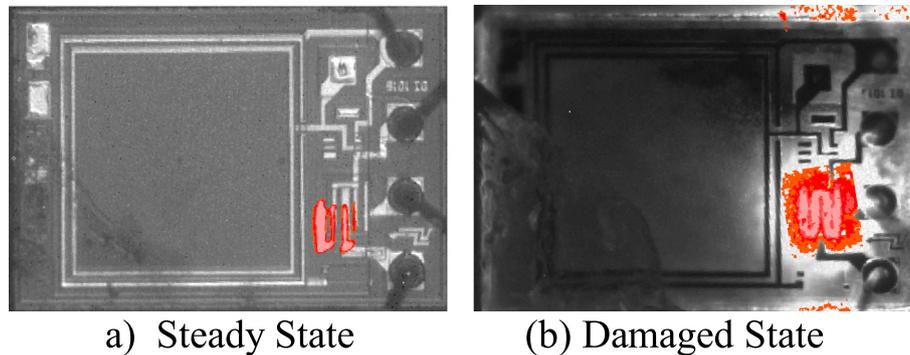
Emission Microscope (EMMI) is well known to detect induced physical damage both at the gate and junction levels [15]. EMMI is able to detect the defect only if the leakage current was in the μ A range. Semiconductor defect resulting from HPEM injection is the cause of the observed leakage current increases.

Despite the leakage current, specimen functioned normally. Therefore, it can be inferred the leakage current is allowed in the product. Fig. 14 shows the leakage current at the p-n junction caused by the fault injection.

Fig. 14. Leakage current position inside the photo-transistor using the Emission Microscope (red part). (For interpretation of the references to colour in this figure legend, the reader is referred to the web version of this article.)
